## Analysis and control of abnormal phenomena in HgCdTe surface treatment

LIU Yan-Zhen, LI Shu-Jie, ZHANG Ying-Xu, XIN Yong-Gang, LI Zhi-Hua, LIN Yang, LI Xiong-Jun,  
QIN Qiang, JIANG Jun, GUO Jian-Hua\*

(Kunming Institute of Physics, Kunming 650223, China)

**Abstract:** The surface treatment is the beginning of the manufacturing process of HgCdTe infrared detector chip, and its quality will directly affect the yield of the chip. The mechanisms of four typical surface anomalies in the HgCdTe surface treatment process were explored using metallographic microscope, scanning electron microscope (SEM) and X-ray photoelectron spectroscopy (XPS) analysis methods, and the corresponding control measures are proposed. The water mark defect is triggered by oxygen absorption corrosion, and this defect can be controlled by rapidly drying the HgCdTe surface with a stable nitrogen gas flow. The staining is induced by the corrosive liquid unevenly diluted or contaminated by impurities such as water. To reduce the probability of staining, the contamination should be strictly avoided in the process, and the surface should be quickly rinsed after corrosion finish. The round spot originates from

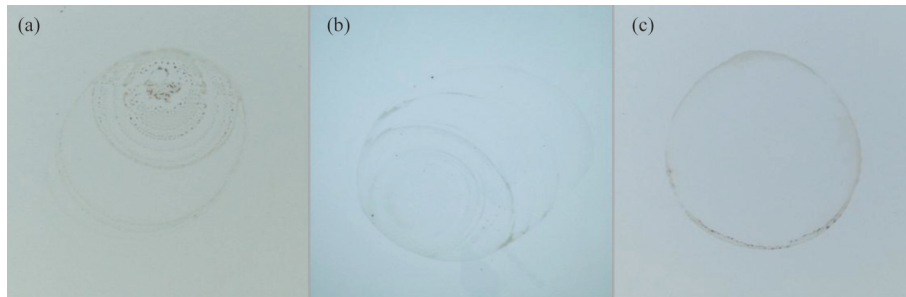
due to its lower value change in the free energy. Additionally, the etching rates of the three components of HgCdTe are  $\text{Cd} > \text{Hg} > \text{Te}$ . The free energy of  $\text{Te}^{2-}$  oxidized to soluble cations is relatively high, which can only be oxidized to  $\text{Te}^0$  by  $\text{Br}_2$ . The slower etching rate of Te will lead to the HgCdTe surface rich in elemental tellurium<sup>[11-13]</sup>. During the cleaning process, water droplets are easily formed on the surface of HgCdTe owing to the  $\text{Te}^0$ -rich surface is hydrophobic, which will induce poor drying and form water mark defects in the  $\text{N}_2$  purge process, as shown in Fig. 1. Water mark defects could compromise adhesion to passivation film, weakening the passivation effects.

Based on the above experimental results, it is easy to form water mark defects on the surface of HgCdTe when the  $N_2$  flow is unstable and the purging time is longer in the atmosphere containing oxygen. The fluctuation of  $N_2$  pressure on the surface of the HgCdTe resulting from unstable  $N_2$  flow tends to induce the formation of water droplets. If the water droplets cannot be blown dry in time, they are inclined to form water trace defects in the process of slow evaporation<sup>[15]</sup>. However, water is often used as the cleaning agent after wet etching of HgCdTe, and no obvious oxidation reaction occur when HgCdTe samples are immersed in water in air. Therefore, the formation mechanism of water mark defects should be oxygen absorption corrosion. In the process of oxygen absorption corrosion, the oxygen transport rate has a great influence on the reaction. At the edge of the water droplet, that is, at the solid-gas-liquid three-phase interface of air on the surface of water HgCdTe, the water content is less, and the dissolved oxygen concentration is higher. The water layer in the center of the water drop is the thickest. In the process of reaction, oxygen in the air is added more slowly by dissolution and diffusion than at

the edge of the water drop, which will cause the difference in the concentration of dissolved oxygen between the center and the edge of the water drop, thus forming the concentration difference corrosion battery. The cathodic reaction is  $O_2+2H_2O+4e^-=4OH^-$ , which is mainly concentrated in the edge region of oxygen-rich water droplets. Oxygen can be quickly replenished from the air, and the generated  $OH^-$  reacts with  $Te^0$  in this area as follows:  $3Te+6OH^-=2Te^{2-}+TeO_3^{2-}+3H_2O$ , and the generated  $Te^{2-}$  and  $TeO_3^{2-}$  can further combine with  $Cd^{2+}$  and  $Hg^{2+}$  to form corresponding compounds. The excess  $OH^-$  can also combine with  $Cd^{2+}$  and  $Hg^{2+}$  to form insoluble hydroxides or oxide precipitation ( $Cd^{2+}+2OH^-=Cd(OH)_2\downarrow$ ,  $Hg^{2+}+2OH^-=Hg(OH)_2=HgO\downarrow+H_2O$ ). The anodic reaction is  $2H_2O+Te-4e^-=TeO_2+4H^+$ , which mainly occurs in the central area of water droplets. With the evaporation of water, the reaction products in water droplets precipitate on the surface of HgCdTe, and obvious water trace rings appear on the edge of water droplets. Therefore, in the surface treatment process, the simplest method to inhibit the formation of water mark defects is to use steady  $N_2$  flow to quickly dry the HgCdTe surface before the  $O_2$  dissolved into the water droplets.

Fig. 1 Three typical microscopic images of water mark defects  
图1 三种典型的水痕缺陷

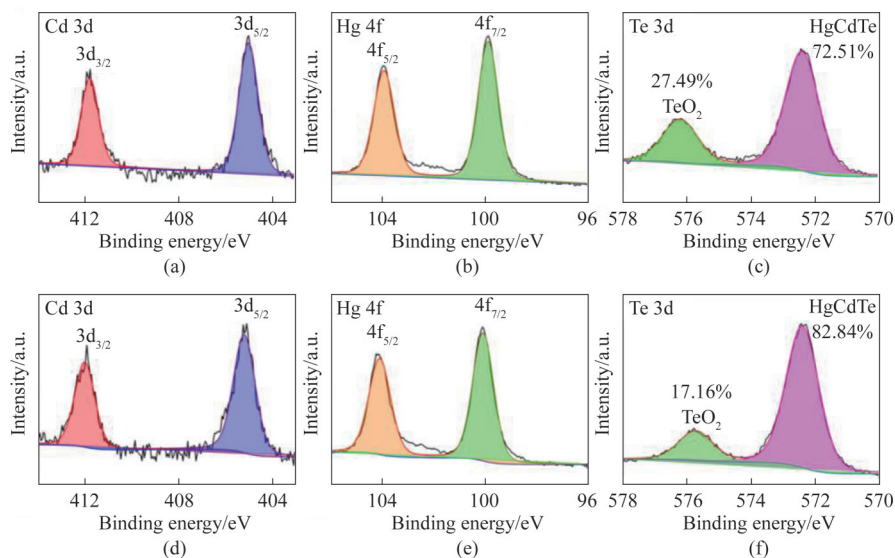
Fig. 2 High-resolution XPS spectra of elements with water mark defect (a), (b), (c), and normal area (d), (e), (f)  
图2 水痕缺陷(a),(b),(c)和正常区域(d),(e),(f)组成元素的XPS高分辨谱

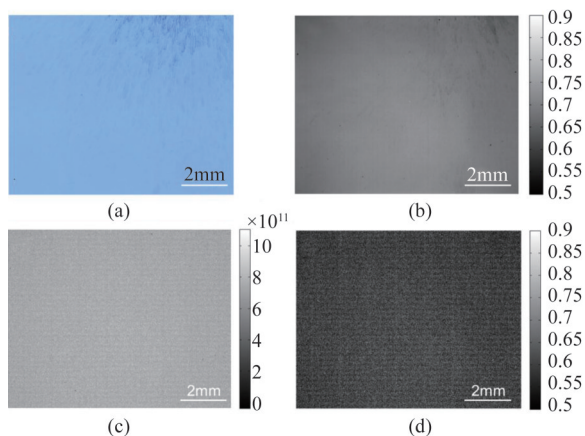
ished by  $\text{Br}_2\text{-CH}_3\text{OH}$  solution, the abnormal phenomenon of some areas staining, commonly known as corrosion patchy, would occasionally occur. Figure 3(a) shows a typical staining phenomenon. These stained films have a direct impact on the pixel response signal in this area, resulting in the “reappear” of irregular imprints in the response diagram (Fig. 3(b)). XPS detection method was used to analyze the element composition of the irregular imprint area, and the test results showed that in addition to Hg, Cd, and Te elements, Br element was also examined, as shown in Fig. 4. According to the XPS high resolution spectrum of C element, the proportion of each oxidation state of carbon element detected in the sample is similar to the conductive adhesive background, so the carbon element detected in the sample may only come from the conductive adhesive. Therefore, the formation of the staining phenomenon should be caused by the uneven etching of different parts by  $\text{Br}_2$  in the wet etching process. According to Fig. 3(b), the pixel response signal in staining area is  $\sim 632$  mV, while the pixel response signal in normal area is  $\sim 694$  mV, demonstrating that the former is 62 mV smaller than the latter. Additionally, it can be found that there is no significant difference between the areas with and without staining both in the spectral detectivity ( $D^*$ ) diagram (Fig. 3(c)) and the noise diagram (Fig. 3(d)), indicating that the staining phenomenon has little effect on the dark current of the device. Thus, the reason for the difference in response between the areas with and without staining is the difference in quantum efficiency of pixels caused by the staining. There are more impurities on the HgCdTe surface of the area with the staining than the other area, which will make the reflection coefficient of the light incident on the lower surface different after passing through the absorption layer, thus affecting the absorption of optical signals by pixels in this area, resulting in low quantum efficiency of pixels.

Fig. 3 (a) Typical microscopic images of staining, (b) the response diagram, (c) the  $D^*$  diagram, and (d) the noise diagram  
图3 (a)典型染色现象的显微镜照片, (b)器件的响应图, (c)  $D^*$ 图, (d)噪声图

non exhibits a higher probability if the speed of methanol washing on the surface was slower or the surface washing agent was not uniform. In these two cases, the residual corrosion solution on the surface of HgCdTe is not uniformly diluted, which will lead to the change of the concentration gradient of etch agent in different areas, resulting in the difference of etching rates. Additionally, it was found that staining tends to form under the condition of  $\text{Br}_2\text{-CH}_3\text{OH}$  solution contaminated by water. Theoretically, the process of wet etching of HgCdTe by  $\text{Br}_2\text{-CH}_3\text{OH}$  is chemical corrosion, and  $\text{Br}_2$  molecules directly collide with the surface of HgCdTe to generate corrosion products. However, when there are impurities such as water in the solution, these impurities act as the electrolyte of ionic conductor, and the electrochemical reaction preferably proceed between HgCdTe and the corrosion solution. At this time, the electrochemical inhomogeneity on the surface of the HgCdTe, including surface chemical

composition nonuniformity, the crystal structure inhomogeneity (such as grain and grain boundary), as well as the inhomogeneity of physical state (such as stress distribution, deformation, etc.), can result in the surface with different potential in some micro areas, inducing electrochemical corrosion. For example, the atomic energy of the defect site on the HgCdTe surface is higher than that of the non-defect site, and the defect site is preferentially corroded as an anode, resulting in the difference in the thickness of the corroded film between the defect area and the non-defect area, and showing different interference colors. Therefore, in order to reduce the probability of staining, it is necessary to avoid the uneven corrosion on different parts of the HgCdTe. Additionally, in the etching process, water contamination should be avoided strictly. When the etch process is completed, the entire HgCdTe surface needs to be washed quickly with a large amount of methanol.

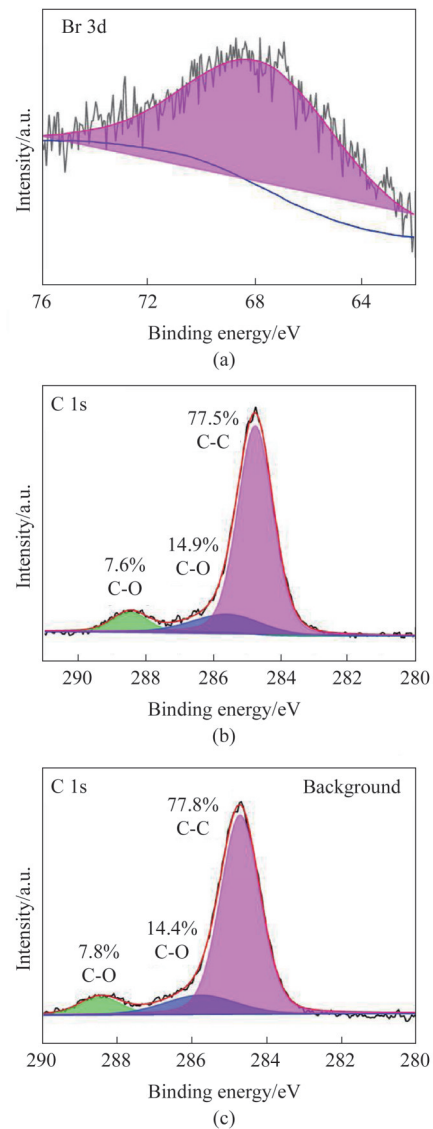
Fig. 4 XPS high-resolution spectrum of Br 3d (a), C 1s (b), and C 1s (conductive adhesive) (c)

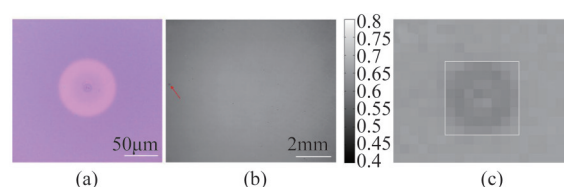
After the passivation film layer is prepared, round spots can be observed on the surface of some HgCdTe samples, and most of these spots are centered on a defect, which generally leads to circular dark spots in the response diagram of the device (a back-illuminated device with the scale of  $640 \times 512$  pixels and the pixel center distance is  $15 \mu\text{m}$  as an example), as shown in Fig. 5. The diameter of the round spot is about  $90 \mu\text{m}$ , and the size of the central material defect is about  $6 \mu\text{m}$ . This material defect does not cause dead pixels, as exhibited in Fig. 5(c), resulting in a smaller response signal of about  $8 \times 8$  pixels (the round spot area is  $\sim 59 \text{ mV}$  smaller than the normal area).

Fig. 5 (a) Typical microscopic images of round spot, (b) the response diagram, and (c) the number of pixels contained in the circular dark spot (a small square represents a pixel)

The  $\text{CH}_3\text{OH}$  molecule has strong polarity and is easily adsorbed at the defect by electrostatic interaction. It was found that after washing the surface of HgCdTe with methanol, soaking the HgCdTe sample with isopropanol, which is less volatile and less polar than methanol, for several minutes, and then drying, could significantly reduce the probability of round spot.

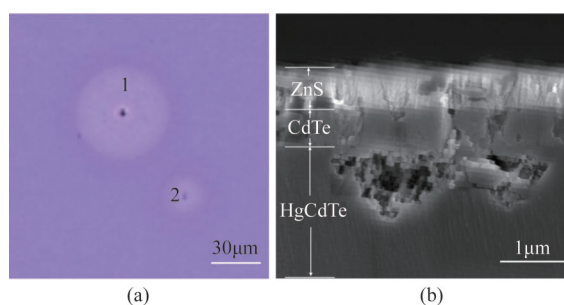
To explore the cause of the round spot, after the ZnS and CdTe passivation films were removed by dry etching, the element composition at the round spot was tested by XPS technology (the test point is one  $10 \mu\text{m} \times 10 \mu\text{m}$  area in the round spot that avoids the central material defect, Mark 1 in Fig. 6(a), another HgCdTe sample), and Hg, Cd, Te, Br, C, and O elements were detected. Figure 6(b) shows the SEM image of the section structure of the defect in the center of the round spot marked 2 in Fig. 6(a), illustrating that the defect originates from the HgCdTe film. Figure 7 shows the XPS high resolution spectrum of Br and C elements. By comparing Fig. 7(b) and Fig. 4(c), it can be found that the C=O and C-O contents of the sample accounted for 11.3% and 30.7%, respectively, which were significantly higher than that of the conductive adhesive (7.8% and 14.4%). The difference of test results indicate that the carbon element detected in the sample comes from both the sample and the conductive adhesive, demonstrating that the C element was contained in the round spot, which can be attributed to the adsorption residue of organic liquid at the defect in the wet process. In addition, according to the process carried out, it can be inferred that Br element originates from  $\text{Br}_2$  residue during  $\text{Br}_2\text{-CH}_3\text{OH}$  etching process. Therefore, it can be concluded that the round spot originates from the defect tending to adsorb wet agent. In the process of wet treatment, some

wet agent will adsorb and remain in the defects due to the large number of tiny pores in the defects. When passivation film deposition, the residual wet agent gradually volatilizes to the defects around forming round spot owing to the temperature increase.

Fig. 6 Typical microscopic images of round spot (a) and the SEM image of material defect (b)

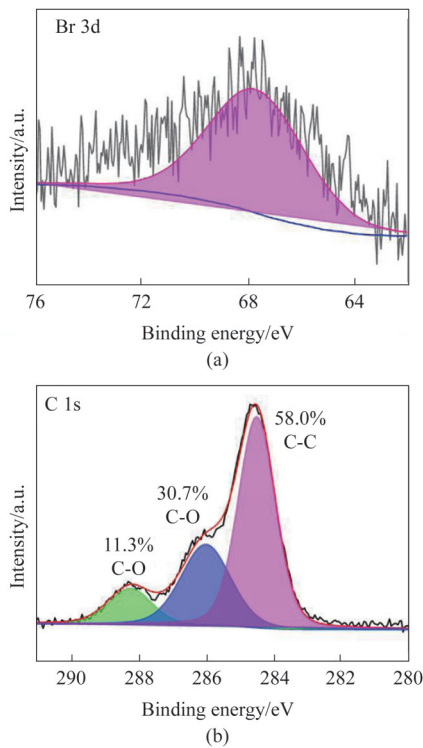
Fig. 7 XPS high-resolution spectrum of Br 3d (a) and C 1s (b)  
图7 Br 3d(a)和C 1s(b)的XPS高分辨谱

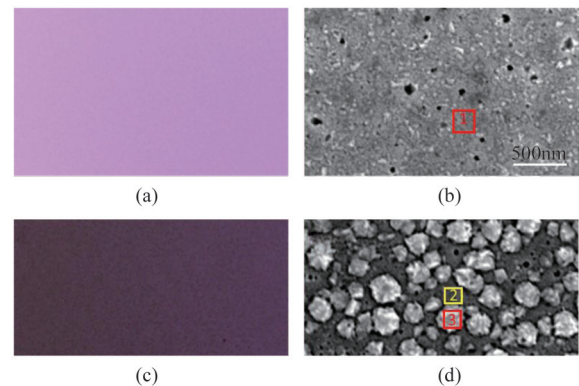
After the passivation film was prepared, another common problem is that the roughness of some areas of some HgCdTe samples is too high, which is manifested as the color is obviously dark (Fig. 8(c)). After the ZnS film removed by hydrochloric acid, the surface morphology of the over-roughness and the normal area was investigated by SEM technology, and the results are shown in Fig. 8. The surface roughness of the normal area is relatively lower, while the surface of the rough area shows obvious large particles. Table 2 presents the results of energy dispersive spectrum (EDS) in normal area (Mark 1 in Fig. 8(b)), non-particle area (Mark 2 in Fig. 8(d)) and particles (Mark 3 in Fig. 8(d)) in over-rough area, respectively. The results demonstrate that the components of these three areas are basically the same. Then, the CdTe film was removed by acid potassium dichromate solution and the morphology was investigated by SEM. The SEM image of normal area is relatively flat, while the surface of the over-rough area has obvious particles

Fig. 8 Typical microscopic images and SEM images of normal area (a), (b), and over-roughness area (c), (d)  
图8 正常区域(a), (b)和过粗糙区域(c), (d)显微镜及SEM下观察的表面状态图

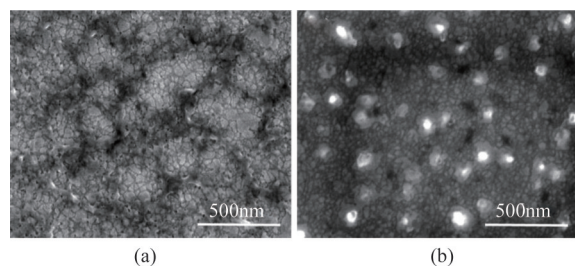
(as shown in Fig. 9). In general, the grains of the passivation film deposited on the surface with small roughness are uniform and compact with lower internal defects. While, the passivation film deposited on the surface with high roughness is porous and loose, showing a higher defect density. During the process of passivation film preparation, on the rough surface of HgCdTe sample, the adsorption energy of adsorbed atom varies greatly, so nuclei are tend to form at the positions with higher adsorption energies, inducing the formation of large particles. For the surface with small roughness, the distribution adsorption position is relatively uniform due to the smaller difference degree of adsorption energy, resulting in the passivation film structure more uniform and compact. Therefore, the phenomenon of over-roughness of passivation film can be ascribed to the larger surface roughness of HgCdTe in this area.

Fig. 9 SEM images of samples after CdTe film removed for normal area (a) and over-roughness area (b)  
图9 HgCdTe 晶片正常区域(a)和过粗糙区域(b), CdTe 钝化膜去除后的表面状态图

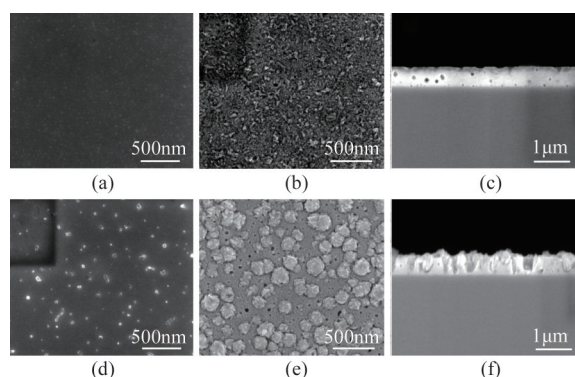
It was observed that the surface roughness of HgCdTe increased significantly when it was immersed in toluene for several hours. For comparison, one HgCdTe sample with uniform surface was evenly divided into two halves and one half was soaked in toluene. Figure 10 shows the SEM images of HgCdTe samples without and with toluene immersion. The surface roughness of the HgCdTe sample without toluene immersion is small, while the sample after toluene immersion shows many large particles, which is consistent with the results in Fig. 9(b). Subsequently, CdTe film and ZnS film were deposited on two samples by conventional process, and ZnS film was removed by hydrochloric acid. Then, the morphology of the as-prepared HgCdTe samples was in-

vestigated by SEM, and the results were shown in Fig. 10 (b) and (e). The surface of sample without toluene immersion is relatively flat and the particle size is small. Additionally, it can be seen from the cross section that there are a few holes in the CdTe film (Fig. 10(c)). While, there are obviously a large number of bigger particles on the surface of sample soaked in toluene (Fig. 10(e)), and these particles are embedded in the CdTe film (Fig. 10(f)), which is similar to the over-roughness phenomenon. It can be concluded that the surface roughness of HgCdTe immersed in toluene increases, which may be caused by a certain interaction between toluene and HgCdTe.

Fig. 10 SEM images of the sample without toluene immersion (a) the surface of HgCdTe, (b) the surface of CdTe, (c) the section structure of CdTe/HgCdTe, and the sample with toluene immersion (d) the surface of HgCdTe, (e) the surface of CdTe, (f) the section structure of CdTe/HgCdTe  
图10 HgCdTe 晶片不同条件下的表面状态图, 未浸泡甲苯(a) HgCdTe 表面, (b) CdTe 表面, (c) CdTe/HgCdTe, 截面 SEM 图; 浸泡甲苯: (d) HgCdTe 表面, (e) CdTe 表面, (f) CdTe/HgCdTe 截面 SEM 图

During the preparation of HgCdTe IR detector chip, some organic impurities on the initial surface of HgCdTe should be cleaned by organic reagents, including toluene, acetone and ethanol, before surface polishing. Thus, the over-roughness problem may be due to the direct contact of toluene with the HgCdTe surface. Through the experiment, it was found that by shortening the soaking time of toluene or using trichloroethylene instead of toluene, the over-roughness problem was obviously controlled. However, the interaction mechanism between toluene and HgCdTe still needs to be further studied.
